# CHAMPLAIN BRIDGE

IMPACTS DUE TO POSSIBLE DELAYS OF NEW BRIDGE OPENING - UPDATE

PROJECT NO.	DOCUMENT NO.	
2038	2038-RPT-GEN-012	
VERSION	DATE OF ISSUE	DESCRIPTION
0	30 Oct 2018

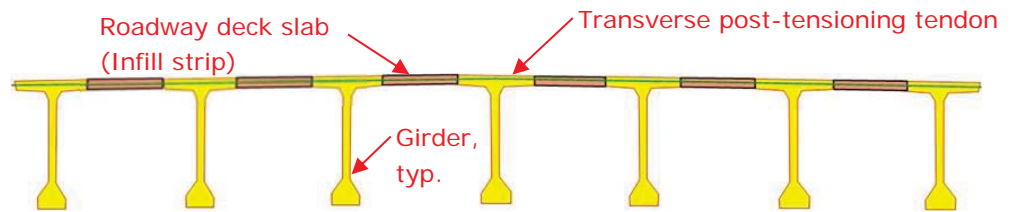
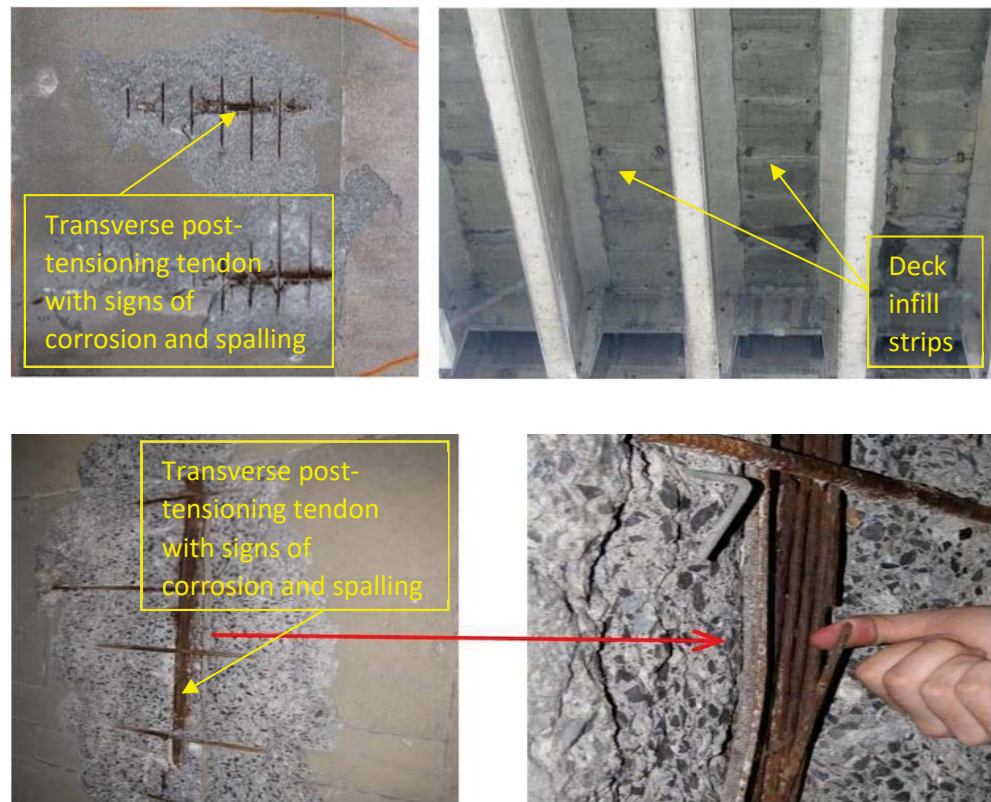
Figure 3 Observed Signs of Deterioration on Soffit of Deck Slab

Figure 3 shows typical observed signs of deterioration on the soffit of deck infill strips. At some locations, there is evidence of corrosion of the transverse post-tensioning tendons in the deck and these tendons are essential to ensure the transverse integrity of the deck slab.

The risk associated with the deck if a serious problem is not identified by JCCBI's inspection team is a local failure in the deck. The most likely result of a local deck failure would be a short-term closure of one or two lanes of traffic (depending on the extent of the local failure).

COWI anticipates that the number of localized deck repairs required per year will continue to increase as time passes.

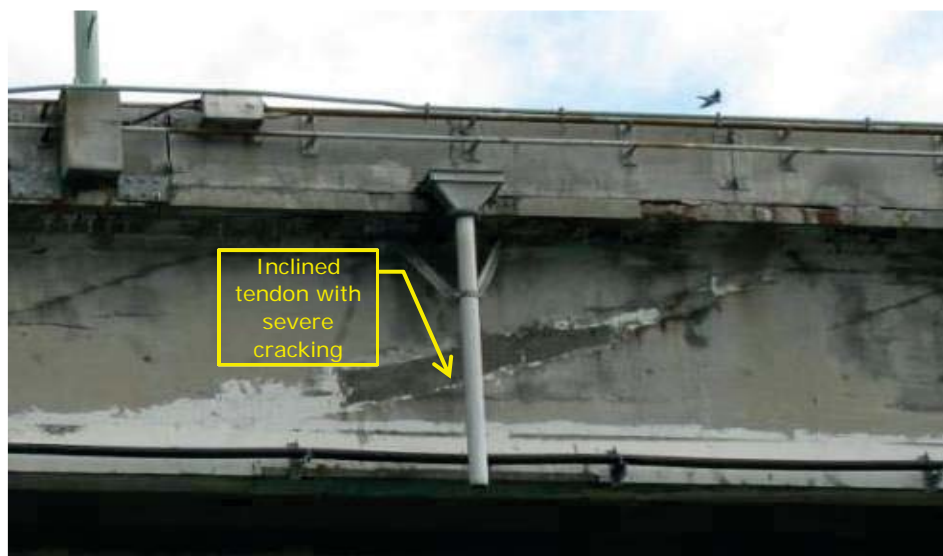
Figure 4 Severe Cracking as Sign of Deterioration of Girder Internal PT

Establishing the amount of PT section loss in a girder is very difficult since only localized openings or surface observations are possible. Although attempts have been made to use non-destructive testing to determine corrosion levels, there is still uncertainty about the actual condition and section loss of the PT tendon and as a result the strength of the girders.

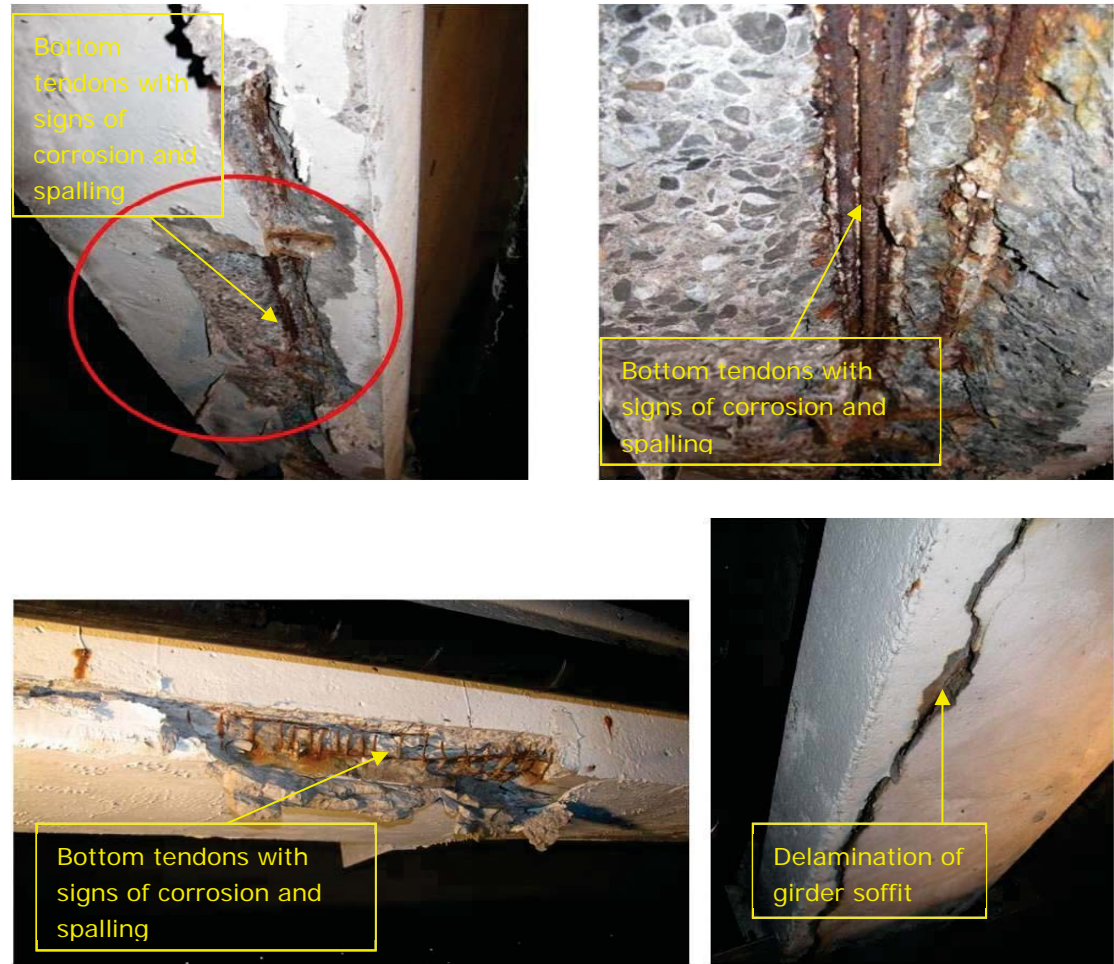
Figure 5 Observed Signs of Deterioration of Edge Girders

In 2013 a very alarming structural failure occurred to one of the 100 edge girders. Fortunately, as part of JCCBI's proactive approach to managing the deterioration of the bridge, a steel support girder ("Superbeam") had been fabricated in 2009 and stored near the bridge, ready to be used in the event of such a failure. Following this girder failure, JCCBI updated its risk mitigation program and launched a major girder strengthening campaign to ensure structural integrity of all 100 edge girders.

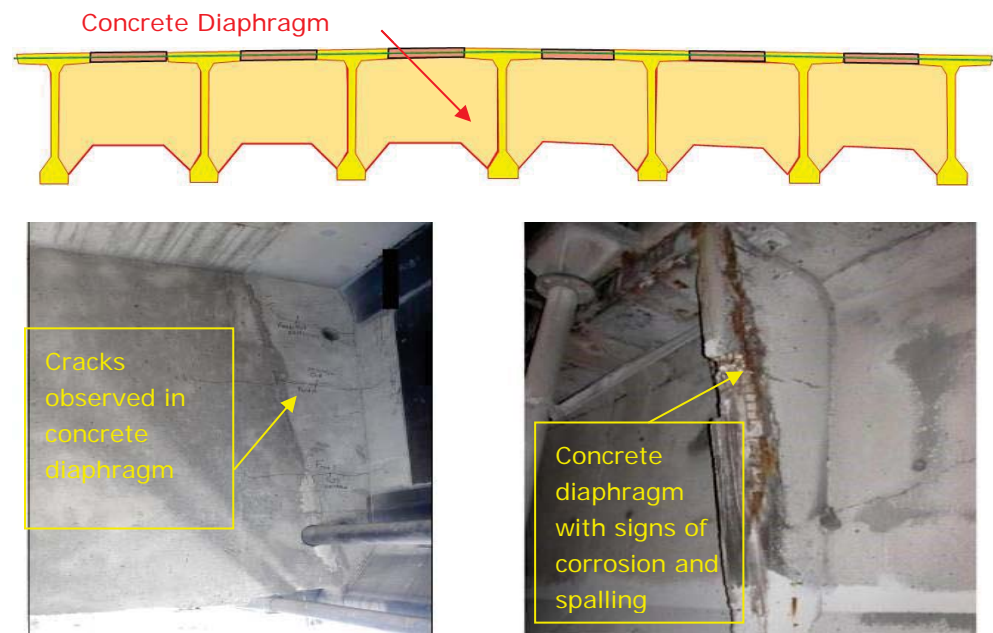
Figure 7 Observed Signs of Deterioration on Concrete Diaphragms

Many of the 1272 concrete diaphragms between the girders in Sections 5 and 7 are in poor condition and show signs of significant deterioration (see Figure 7). At some locations, corrosion of reinforcement, concrete spalling and cracking have been observed. The concrete diaphragms provide load sharing between girders under traffic, and deterioration to these components increase the girder demands and, in turn, the risk. In the last 5 years, many of the diaphragms have been strengthened.

COWI considers that there is a medium risk of failure of a concrete diaphragm. This risk will remain medium under the 6 and 12 month delay scenarios due to the mitigation measures completed by and recommended to JCCBI in 2017 and 2018 (fabrication of a Super Diaphragm, the award of a contract for an "emergency" installation if needed, and increased inspection frequency to every 4 months).

The consequence of a failed concrete diaphragm may require a lane closure on the bridge until it is rehabilitated. JCCBI continues to carry out frequent inspections to closely monitor for signs of distress in the diaphragms. In 2018, COWI developed a concept for strengthening a distressed concrete diaphragm, called the "Super Diaphragm", to provide relief to the distressed diaphragm and the rest of the superstructure. A Super Diaphragm has been fabricated and is currently available for deployment as it is stored in JCCBI's maintenance yard. As part of the 2018 mitigation plan outlined in Section 4.2, JCCBI plans to issue and award a contract for an "emergency" installation (if required) such that a Contractor will be capable of quickly installing the Super Diaphragm should diaphragm distress occur.

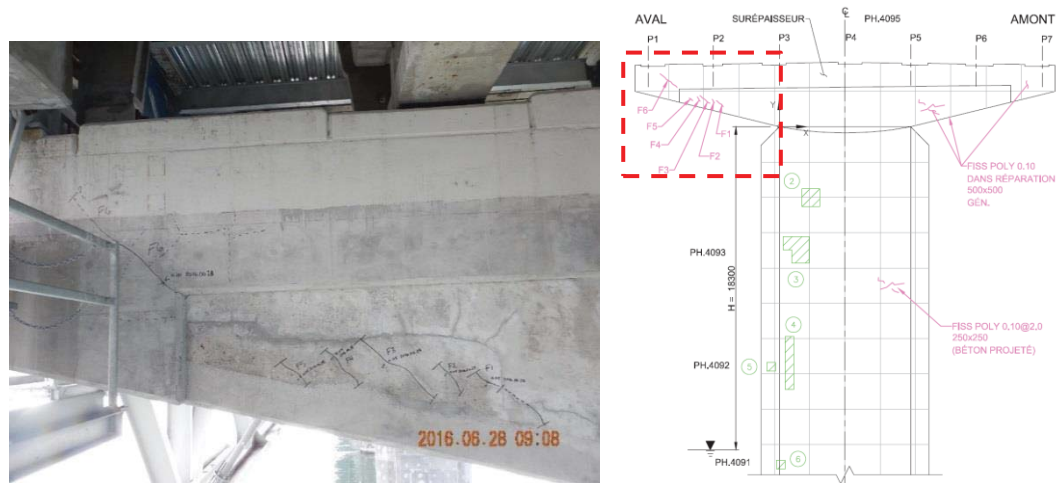
Figure 8 Observed Signs of Deterioration on Pier Caps (Pier 18W shown)

The pier caps of the concrete spans have been retrofitted many times over the years – the most significant interventions were carried out between 2002 and 2013. At the time, significant deterioration of the pier caps, including structural cracking, was observed. Inspections of the pier caps completed in 2016 and early 2017 identified cracks that could be a sign of structural distress (see Figure 8).

Even with the retrofits and strengthening systems that were added to the pier caps between 2002 and 2013, they are very highly stressed. In addition, due to the ongoing deterioration there is a possibility that unseen defects exist within the pier caps that would potentially affect their load carrying capacity. Since the pier caps have no redundancy, severe distress of a pier cap would result in a complete closure of the bridge, and a complete failure of a pier cap would result in the collapse of two spans of the bridge.

In 2017, COWI developed a concept for a strengthening system that will relieve the high stresses exhibited by the pier caps in the zones of concern. The aim of the concept is to relieve the high compressive forces in the zones of concern, and to allow for rapid installation in the event that an urgent situation needs to be addressed. This strengthening system is called the "Super Post" and is shown in Figure 9. In September 2017, COWI considered the risk associated with the pier caps to be medium which would change to high with either a 12 or 24 month delay to the new bridge. Therefore, due to the possible delays of up to 24 months beyond the original commissioning date of the new bridge, JCCBI elected to fabricate and install a Super Post System on 39 of the most critical pier caps in order to reduce the demands on these components. Super Post Systems are not required for the remaining 9 pier caps given their current condition and a maximum anticipated delay of 12 months.
