# Deconstruction of the Existing Champlain Bridge

## Targeted Environmental Analysis

Description of the Project and the Environment

November 2019  
Contract No 62555

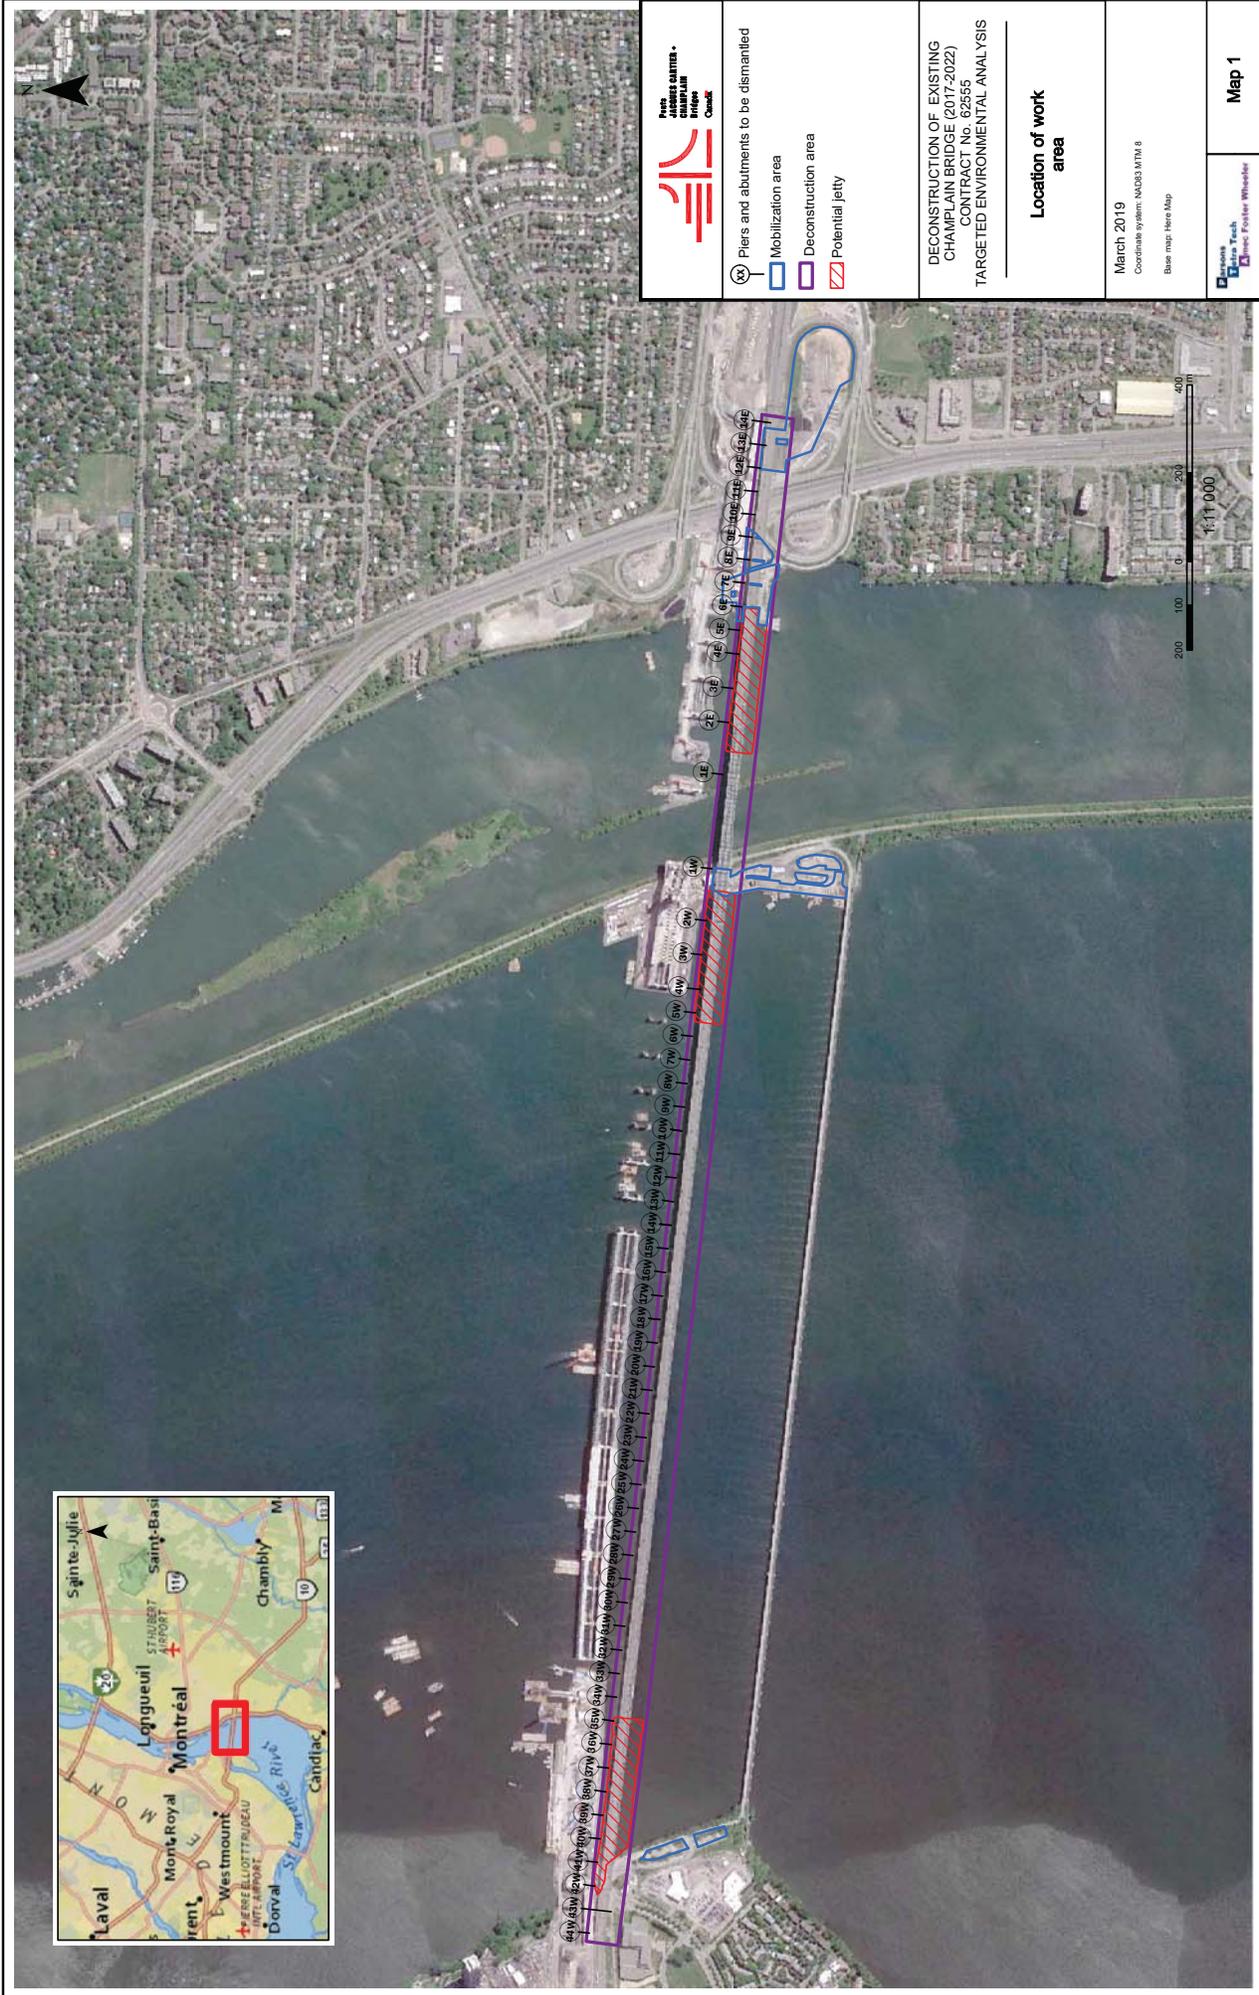
- Piers and abutments to be dismantled
- Mobilization area
- Deconstruction area
- Potential jetty

This section presents the scenario for the deconstruction of the Existing Champlain Bridge as considered by the draft design study conducted by PTA (2017). Given the bridge's size, it was divided into sections (see Table 1 and Figure 1). Piers 44W to 41 W (Nuns' Island side), 1W (dike) and 6E to 14E (Brossard) are located over land, while the other piers are located over water.

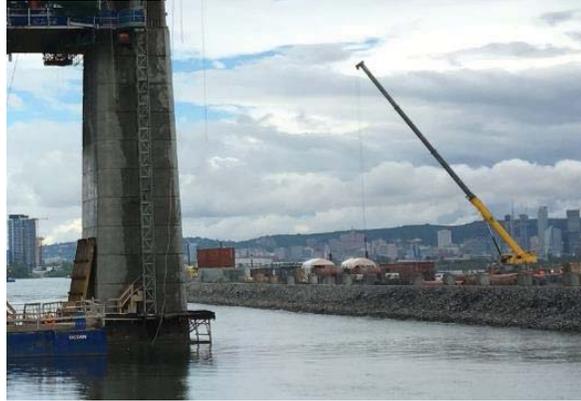
**Photo 1 – View of a jetty for the construction of the New Champlain Bridge from the Seaway dike**

A temporary jetty is an access solution for shallow areas. These jetties are generally made of backfill placed in the waterway and removed once the work has been completed. Access by jetty allows the same work methods to be used as for work over land. A jetty will have environmental and hydraulic impacts on the St. Lawrence that must be taken into account. A few sections of the New Champlain Bridge are being built from temporary jetties (Photo 1 and Photo 2). Part of the materials from the jetties are expected to be reused. These will be temporarily stored in mobilization area D, in Brossard, and in a new area E, on the Montreal side (see Appendix 14). These materials will be characterized before being temporarily stored to make sure they are free of contamination and comply with the requested grain size.

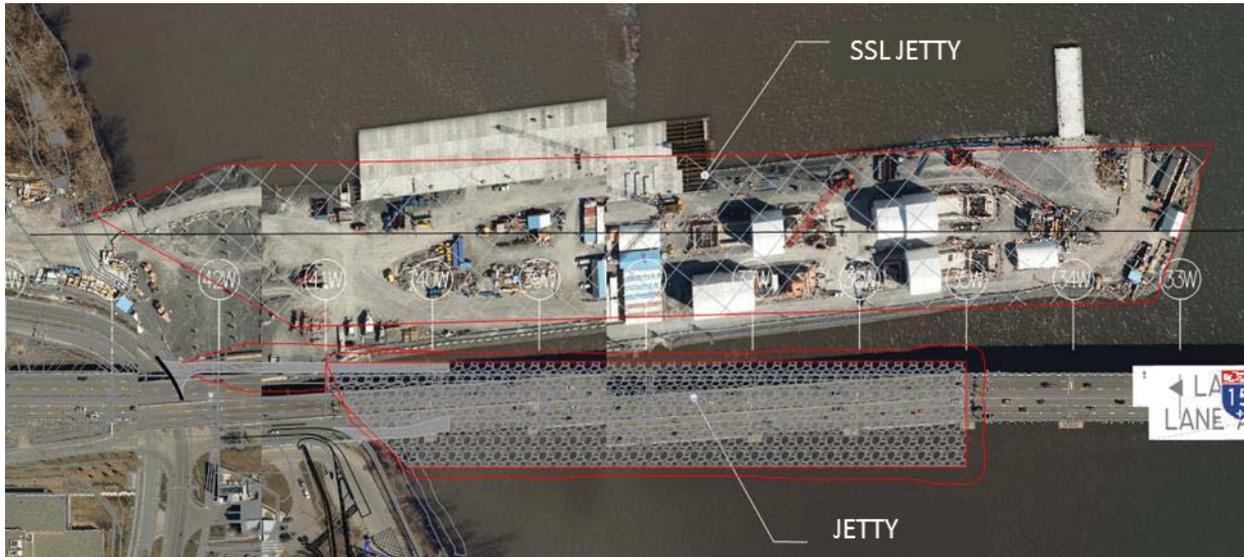
Figure 2 – Drawing – Proposed jetty on the Nuns' Island (IDS) side – photo: April 2016

The jetty on the Nuns' Island side (Figure 2), between axes 41W and 35W (Figure 3 and Figure 4), is required since the water depth does not allow these spans to be accessed by water. This jetty is slightly wider than the other two so that an access ramp can be built. The other two jetties provide continuous access to the spans rather than for a definite period. In fact, on the Brossard side, the water level is lowered when the Seaway is closed, which does not allow barges to be used. In addition, work from a jetty is easier to carry out and offers more flexibility, such as with respect to the weight and size of the allowed equipment and the transportation of materials.

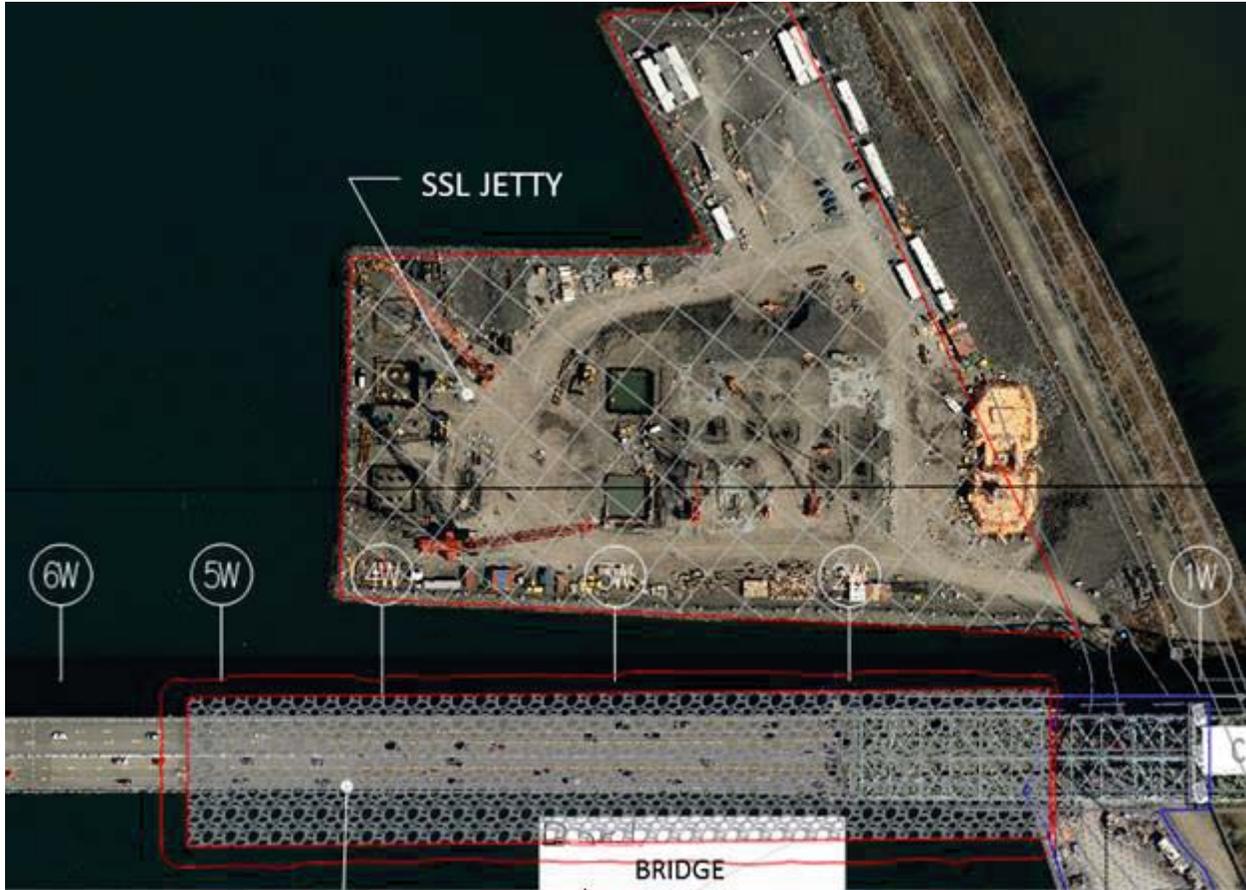
Figure 3 – Drawing – Proposed jetty in the Seaway dike – photo: April 2016

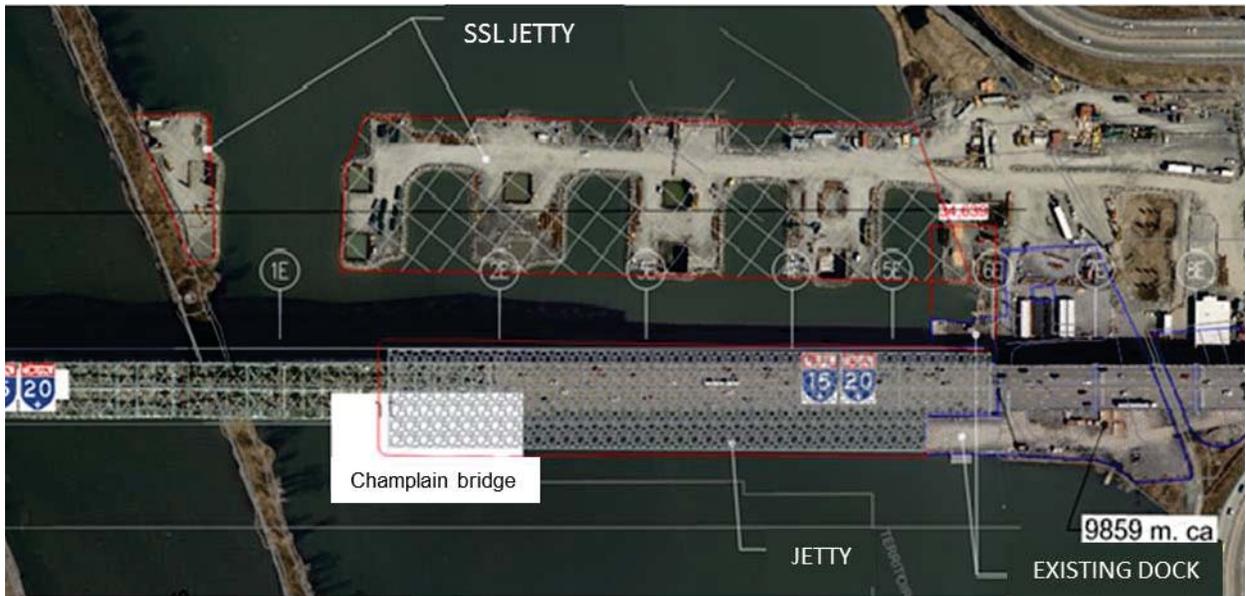
Figure 4 – Drawing – Proposed jetty in Brossard – photo: April 2016

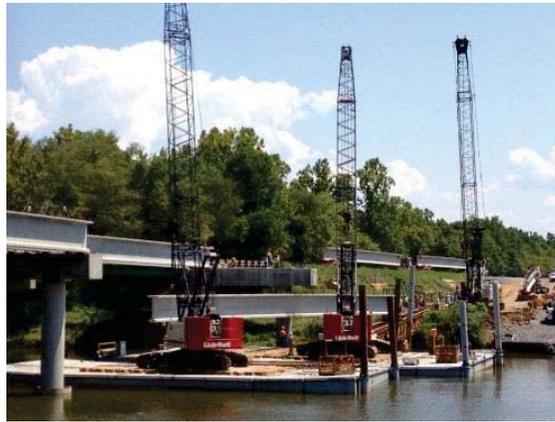
Photo 3 – Floating wharf

A floating wharf could be considered for accessing low-draft areas (Photo 3). The floating wharf is made up of modular pontoons (e.g. flexifloat) placed side-by-side and interconnected. The pontoons act as a platform for a provisional deck that will serve as a work area. For shallow areas, some barges can be used by having them sit directly on the riverbed. Depending on the load to be supported, a combination of several pontoons is possible to increase their load-bearing capacity. It is even possible to increase the width of the resulting work area in this way. Naturally, the floating wharf would have to be kept stable, (Photo 4), in particular in relation to the current. Various solutions are possible, such as cables attached to the shore or to moorings on the riverbed. In any case, a system is needed that can operate with the shallow waters and variability in water levels depending on the season.

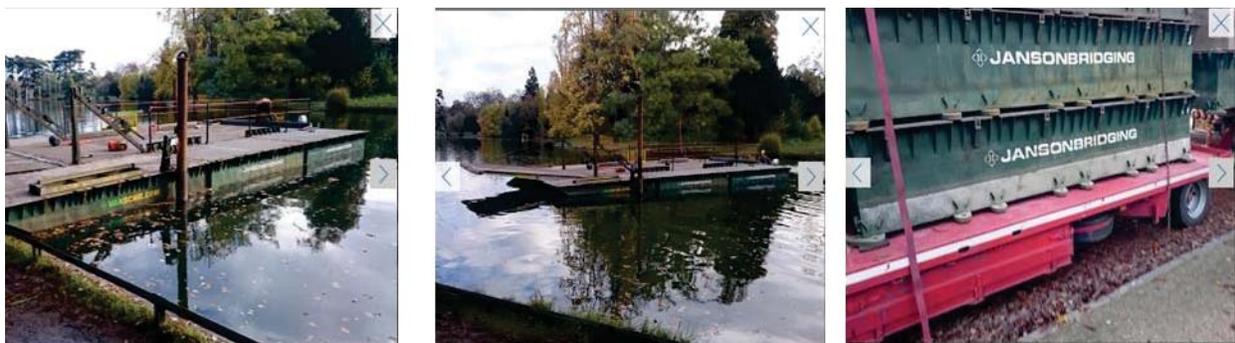
Photo 4 – Floating wharfs/pontoons

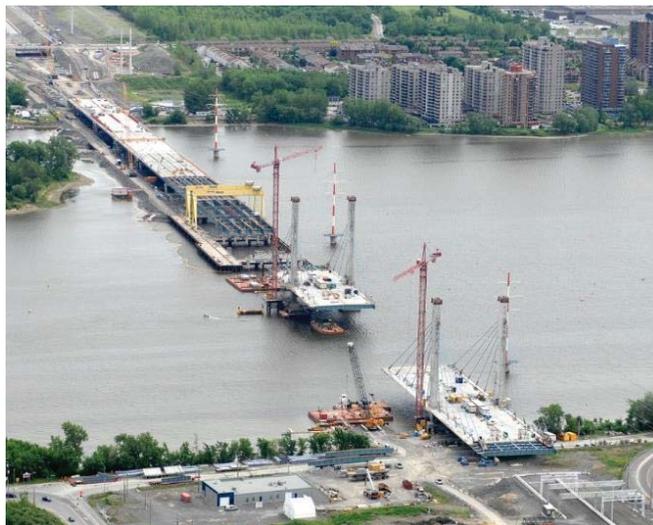
Photo 5 – Highway 25 Bridge: Overhead gantry for approach spans

Use of an overhead gantry is also possible. This system was namely used to build the approach spans for the Highway 25 Bridge. As shown on Photo 5 and Photo 6, it was made up of two gantries with a high lifting capacity and operating on a temporary rail installed under the piers. This type of system could allow girders and pier elements to be handled as part of the deconstruction of the Existing Champlain Bridge. In comparison, the Highway 25 Bridge is slightly wider than the Champlain Bridge, but for its deconstruction, the loads to be handled are much greater. It would be possible to drill caisson piles on either side of the existing deck to install a temporary structure that supports a rail above the St. Lawrence's water level. The gantries would then be chosen to be high enough to allow the girders and piers to be handled between spans 36W and 41W. However, this access provides less flexibility for the deconstruction of the foundations and the laying of the piers, which will be between the Existing Bridge and the New Bridge, which is not easy to do.

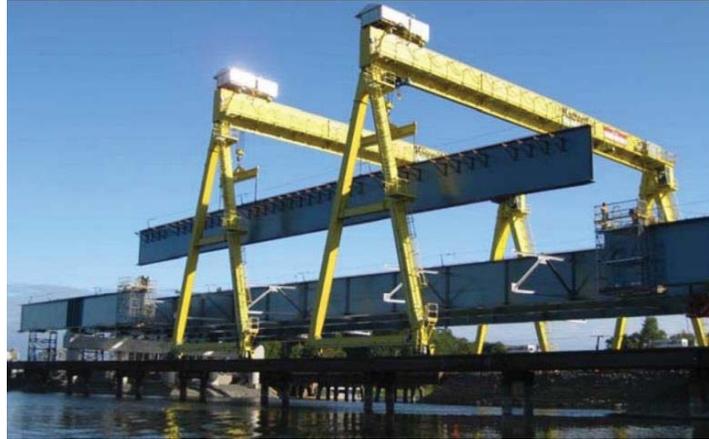
Photo 6 – Highway 25 Bridge: Two lifting gantries running on rails

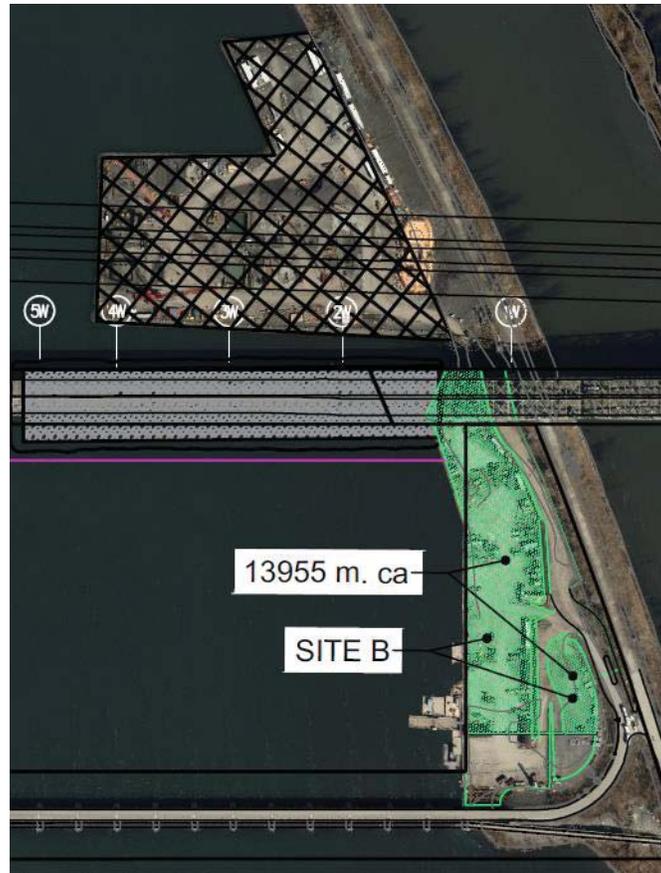
Figure 6 – Mobilization area and dismantlement and handling site “B” – Seaway dike

This mobilization area is located at the base of pier 1W on the St. Lawrence Seaway dike. It is currently used for maintenance work on the Existing Champlain Bridge and can be accessed by road via the Champlain Bridge Ice Control Structure. It is a private road under the jurisdiction of JCCBI. The dike can also be accessed by the river, and various docks have been set up there (Figure 6). This area is dismantlement and handling site "B."

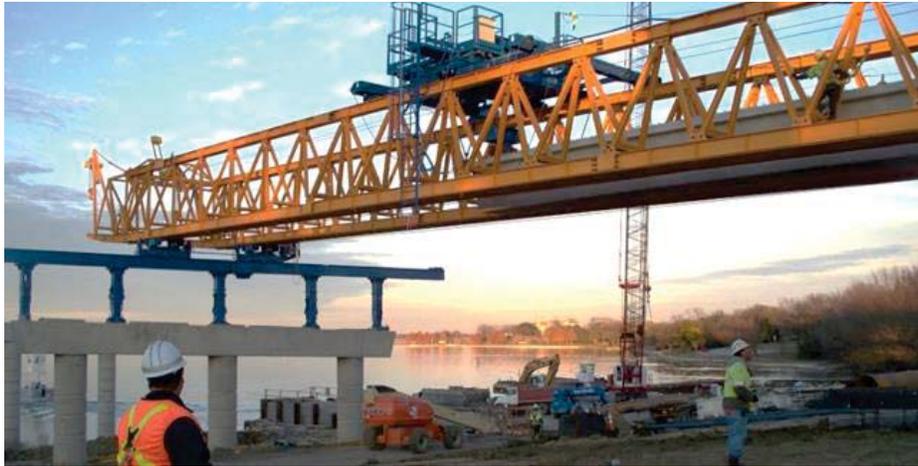
Photo 7 - Launching gantry

The unlaunching method stems directly from the method used to build the current bridge structure, as well as for many works of this type, by “inverting” the construction process using a metal frame called a “launching gantry.” The principle consists of separating the girders, such as by sawing the middle slab and crossbeams, before they are picked up by the launching gantry. Launching gantries are generally made up of two main interwoven steel trusses (Photo 7). Their total length is close to twice the span to be crossed.

The weight of the launching gantry may constitute a disadvantage since it must be supported by the structure. However, the standard designs avoid having the launching gantry rest on the deck when in motion and when handling girders. As shown in Figure 9, the launching gantry stands on two or three supports, depending on the project phase, and is supported at the piers.

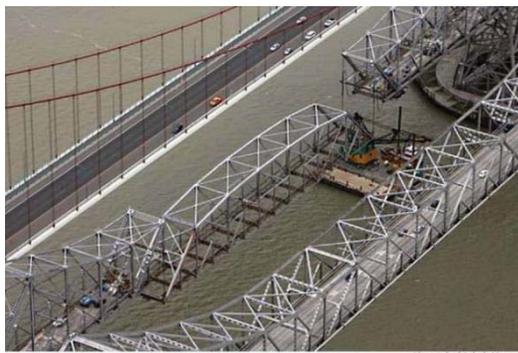
**Photo 8 – Lowering of Carquinez Bridge suspended span**

For the Existing Champlain Bridge main span structure, the suspended span is designed as an independent unit that is suspended at the end of the cantilever structures. Stranded-wire jacks would be placed at the end of the cantilever spans and the wires would also be anchored at the ends of the suspended span trusses. The suspended span would be removed from the main structure and placed on a barge below. Two examples are shown in Photo 8 and Photo 9.

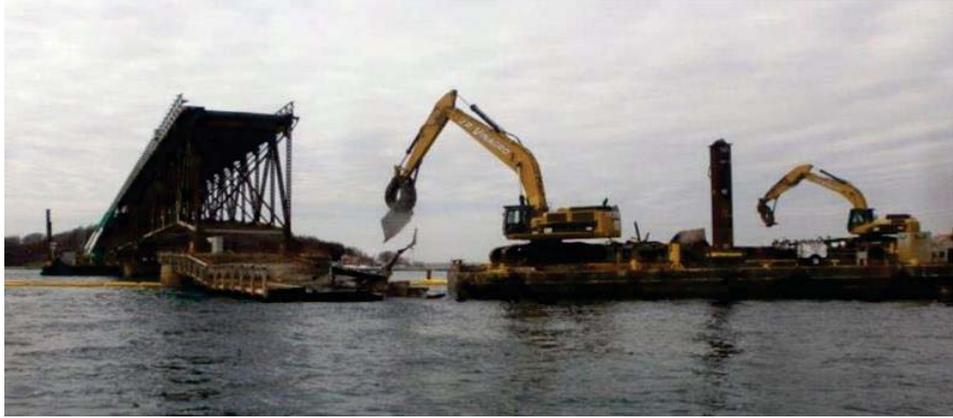
**Photo 11 – Conventional barge method used for the demolition of the Long Island Bridge in Boston Harbor**

Among the usual techniques used with the standard method (Photo 11), those being considered include hydraulic and pneumatic hammers, concrete crushers with shear jaws, and sawing. Some technologies are only suitable for partial demolition and cannot be considered effective for full demolition, especially given the size of the Existing Champlain Bridge. Hydrodemolition, splitting and thermal cutting and drilling could be used, but in specific cases. Wrecking balls and cranes are also not being considered on a large scale as there is less control with this type of demolition.

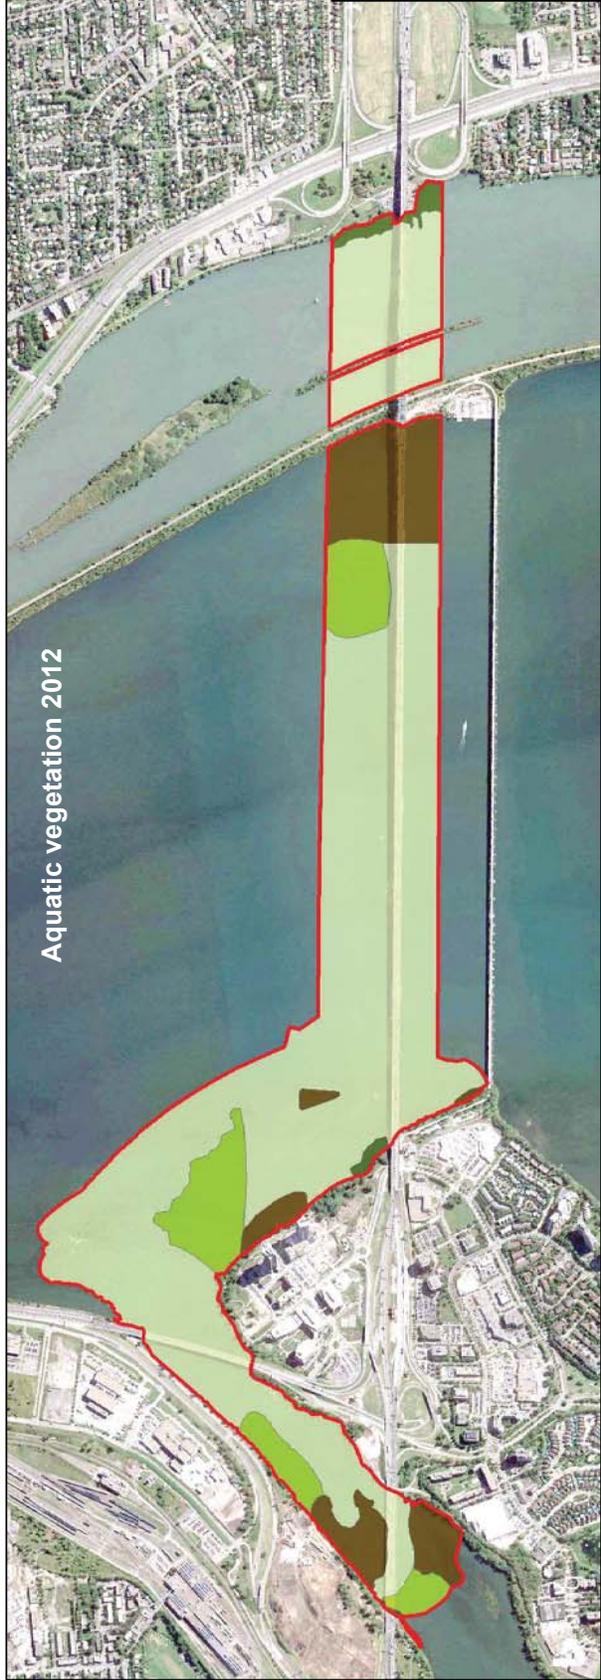
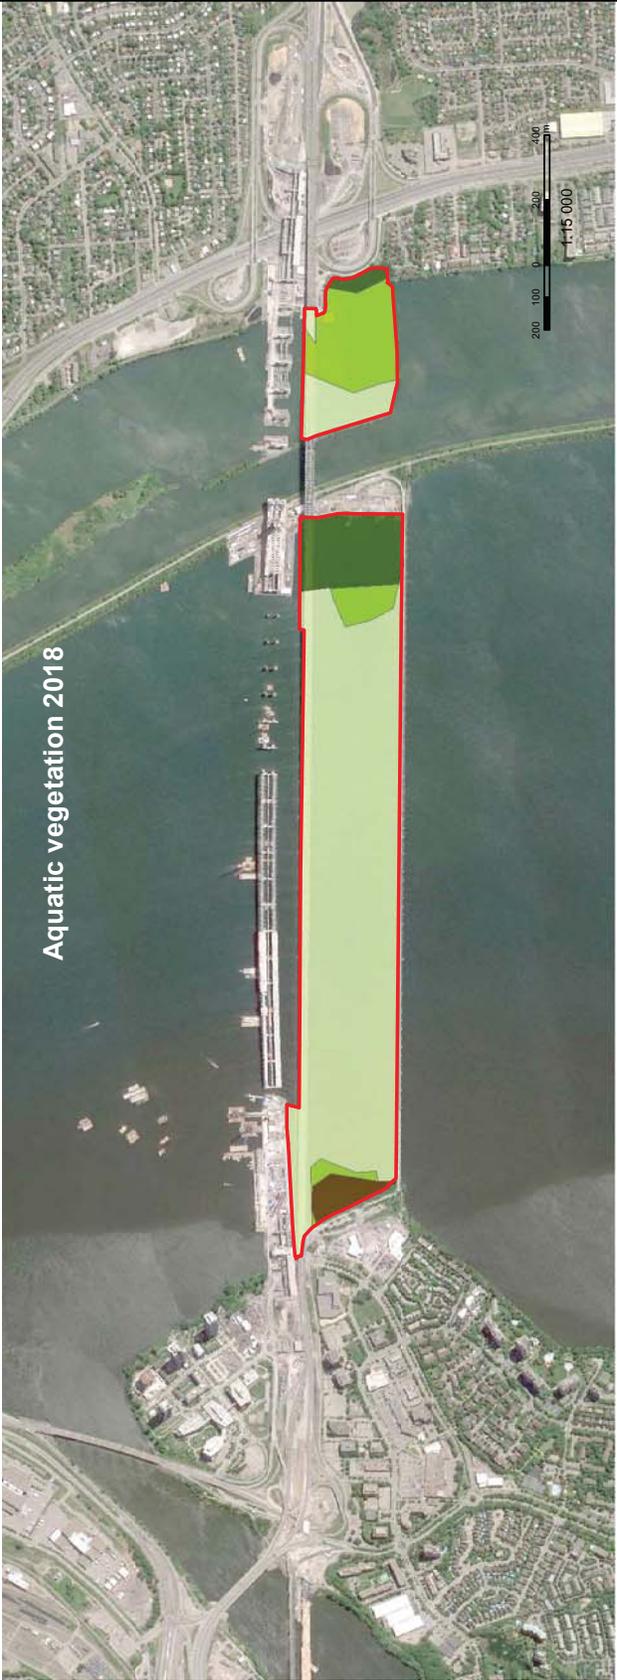
Aquatic vegetation 2012

Aquatic vegetation 2018

During the 2018 aquatic surveys, the aim was to delineate the aquatic plant communities and establish the percentage of aquatic vegetation cover, though without identifying all the plants they contained. Map 4 presents the delineation of the aquatic plant communities in 2012 and 2018.

A marked growth in the aquatic plant communities is noted upstream of the jetty east of Nuns' Island. This jetty has a localized impact on the water flow in this area. In fact, before the jetty was created, current speeds were greater and aquatic vegetation was only found near the Nuns' Island shore. Now there is a lentic flow where there was previously fast-flowing water before the jetty was created. The low water flow in this area appears beneficial for the establishment of aquatic vegetation, which now covers a surface area of about 27,720 m<sup>2</sup> compared to only 2,000 m<sup>2</sup> in 2012.

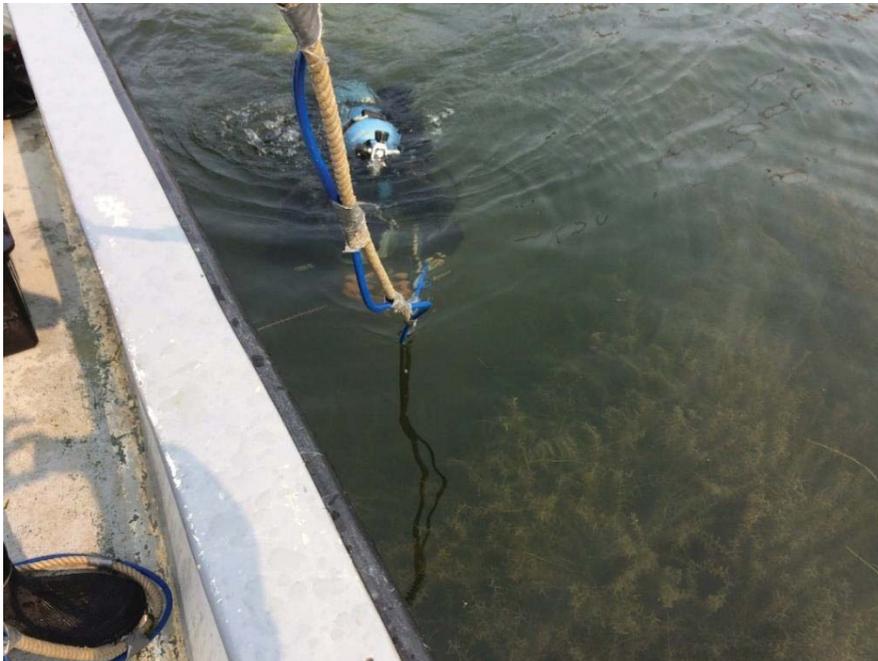
**Photo 12 – Aquatic survey using a diver**

The characterization surveys for the substrate and plant communities were conducted from August 24 to 27, 2018. An underwater camera was used to take pictures of the substrate and aquatic vegetation (Photo 12). The transects were determined based on those characterized by Dessau-CIMA+. Some transects were extended upstream to cover the new study area, and transects were added in the Dessau-CIMA+ study area to again characterize some sensitive habitats (e.g. sensitive habitats near jetties). The video images of the 19 transects covering the study area were georeferenced and saved. Current speeds were measured with a current meter near the surface at the beginning and end of the transects. Based on environmental conditions during the sampling (e.g. current speed), the video recordings were sometimes made directly by a diver or from the boat with a camera attached to a ballasted metal cage.

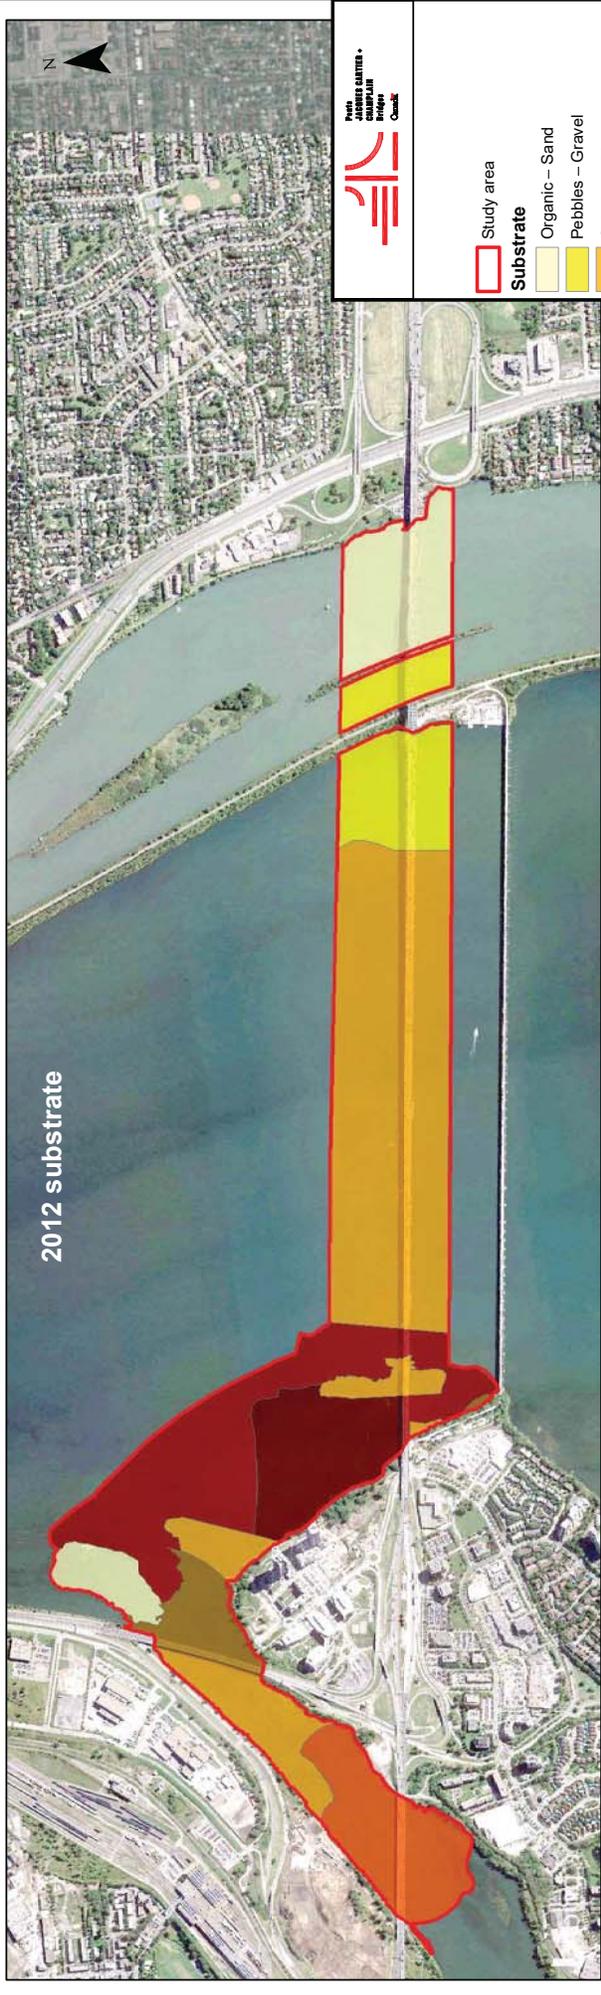
2012 substrate

About 50% of the Greater La Prairie Basin is made up of coarse substrate and has no vegetation, just like the middle section extending under the Existing Champlain Bridge (Map 4). The depth of this section, which presents a laminar water flow pattern, ranges from 2 m to 15 m (types 17 and 20). Two main sections alongside Nuns' Island are noteworthy. The combination of coarse substrate, a depth of less than 3 m and the fast-flowing cross current has created two zones, the first, comprising approximately 69,740 m<sup>2</sup>, downstream from the Clément Bridge, and the second, 28,180 m<sup>2</sup>, downstream from the Existing Champlain Bridge (type 22), both with favourable spawning conditions for several fast-flowing water lithophilous species such as Walleye and Catostomidae.

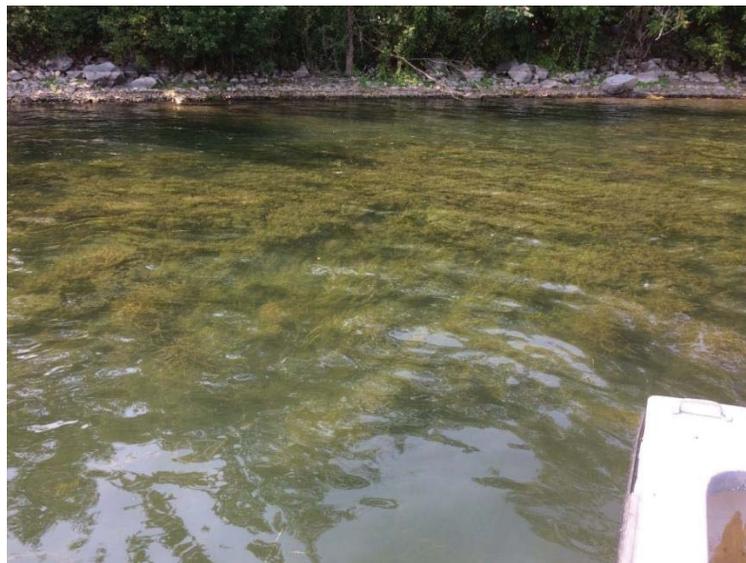
**Photo 13 – Aquatic plant community on the left shore of the Greater La Prairie Basin (type 2 habitat)**

The SSL jetty on the eastern side of Nuns' Island has an impact on the water flow in this area (see Map 9). In fact, before it was created, current speeds were greater and there was only a little vegetation near the shore. Now there is a lentic flow where there was previously fast-flowing water. In fact, the type 22 habitat, a site suitable for the spawning of lithophilous species in fast water, has temporarily disappeared. The low water flow in this area appears beneficial for aquatic vegetation, which now covers about 27,270 m<sup>2</sup> (Photo 13).

The type of habitat is mainly type 2. In 2012, only 2,000 m<sup>2</sup> of type 12 habitat was found near the Ice Control Structure in this area. The plant bed that has developed begins just upstream of the Existing Bridge. Type 2 and 12 sensitive habitats temporarily provide a potential spawning ground for phytolithophilous and phytophilous species. At that location, a slight build-up of sediment can be noted on the coarse substrate in the type 3 habitat (reproductive potential for lithophilous species in slow water) that is currently found now that there is a jetty.

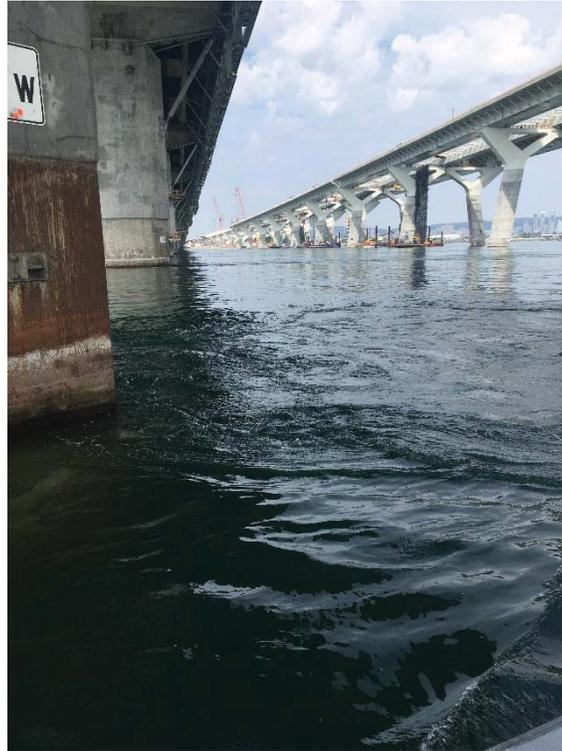
**Photo 14 – Turbulence behind a Champlain Bridge pier**

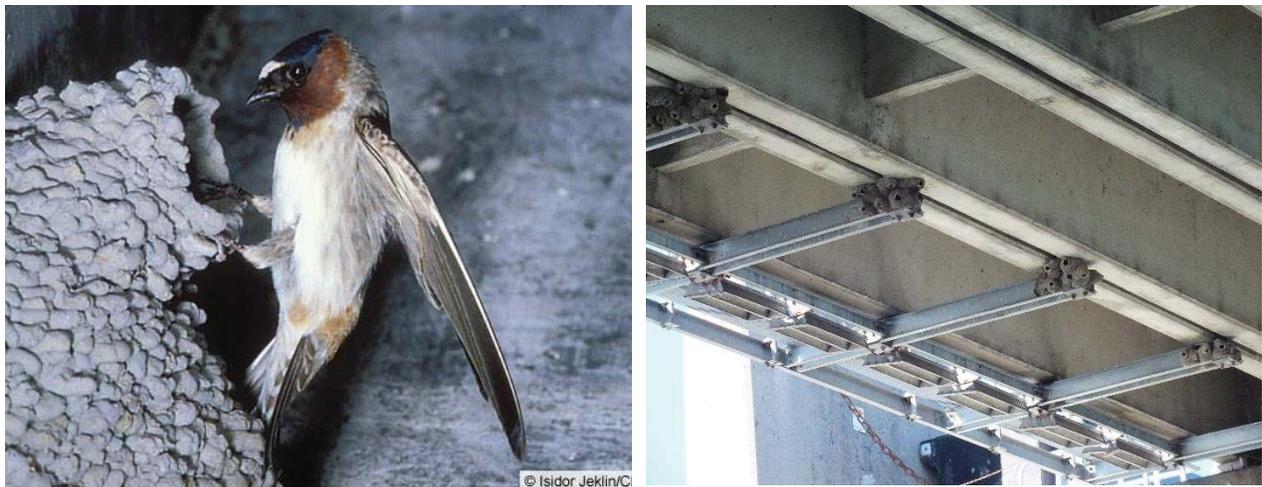
**Photo 18 – Cliff Swallow using beams for nesting**

In general, the nests on the Existing Champlain Bridge are located under the deck at the junction of a diaphragm or under the beam, at the junction with a diaphragm (this is also the case for the Clément Bridge). Nests are also found in diaphragm holes or in the metal cavities of the posts on the Existing Champlain Bridge.

The Cliff Swallow population on the Ice Control Structure has been on the rise, with the highest numbers ever seen since inventories were begun in 2013 (Map 10). This increase may be due to couples relocating from the Existing Champlain Bridge to the Ice Control Structure. In addition, the beams added in 2015 provide a prime habitat for Cliff Swallows since these structures are almost all used to their maximum capacity. They represent a significant advantage for maintaining the Cliff Swallow population of the Existing Champlain Bridge and associated structures (Photo 18).

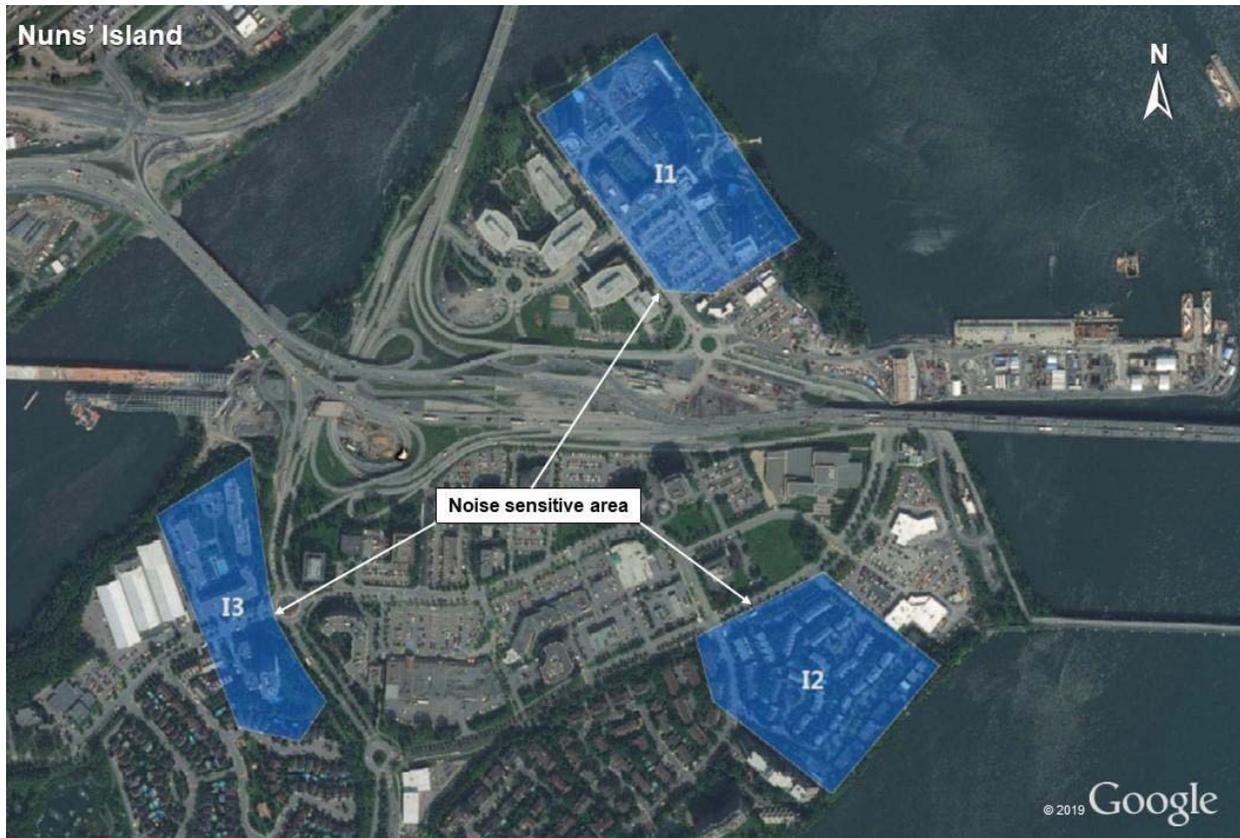
Figure 38 – Noise sensitive areas on Nuns' Island

Three areas in both Nuns' Island and Brossard where noise was being monitored before and during construction of the New Champlain Bridge were also considered as sensitive to noise for the

deconstruction of the Existing Champlain Bridge and are used to consider the sound environment related to deconstruction work and the transport of materials. These areas are shown in Figure 38 and Figure 39. Note that schools and hospitals are located further from the works than the sensitive areas that were identified, and therefore, if noise levels are observed in sensitive areas, they will also be observed around schools and hospitals (the criteria are the same for residential neighbourhoods, schools and hospitals).
