# CHAMPLAIN BRIDGE

IMPACTS DUE TO POSSIBLE DELAYS OF NEW BRIDGE OPENING - UPDATE

PROJECT NO.	DOCUMENT NO.	
2038	2038-RPT-GEN-012	
VERSION	DATE OF ISSUE	DESCRIPTION
0	30 Oct 2018

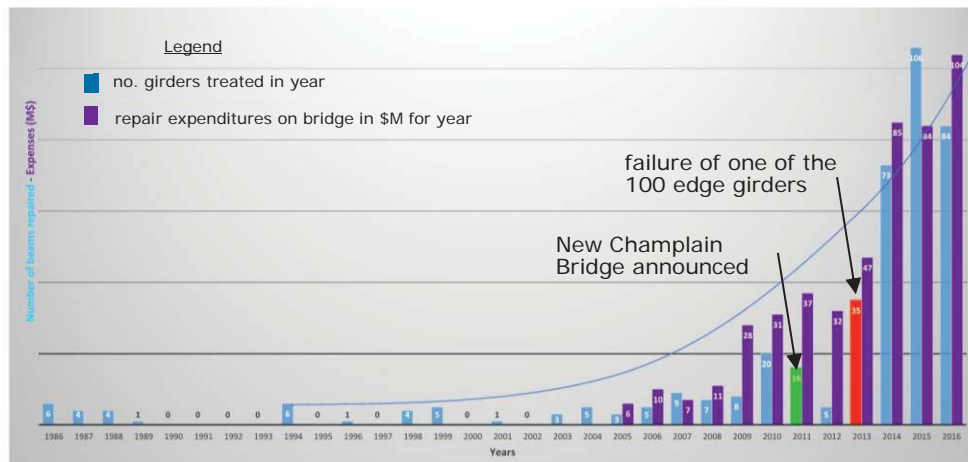
Figure 2 History of Girder Repairs for the Champlain Bridge between 1986 and 2016

In the last 5 years, the action plan developed in 2013 has been continuously updated and additional measures have been required, due to the exponentially accelerating deterioration in the girders and piers. Figure 2 shows the number of girder interventions per year as well as the total expenditures on the overall repairs to the Champlain Bridge per year since the first interventions in 1986. This figure shows the increase in interventions over time for the girders of the Champlain Bridge that have been required to maintain user safety and keep the bridge open to traffic. This also shows JCCBI's significant investment in rehabilitating the bridge since the failure of one of the edge girders in 2013 due to continued corrosion and deterioration of the structure.
